**STRESS - CORROSION AND CORROSION - FATIGUE  
SUSCEPTIBILITY OF HIGH-STRENGTH  
ALUMINUM ALLOYS**

**G.E. NORDMARK, B.W. LIFKA, M.S. HUNTER,  
AND J.G. KAUFMAN**

**ALUMINUM COMPANY OF AMERICA  
ALCOA RESEARCH LABORATORIES  
NEW KENSINGTON, PA.**

**TECHNICAL REPORT AFML - TR - 70 - 259  
NOVEMBER 1970**

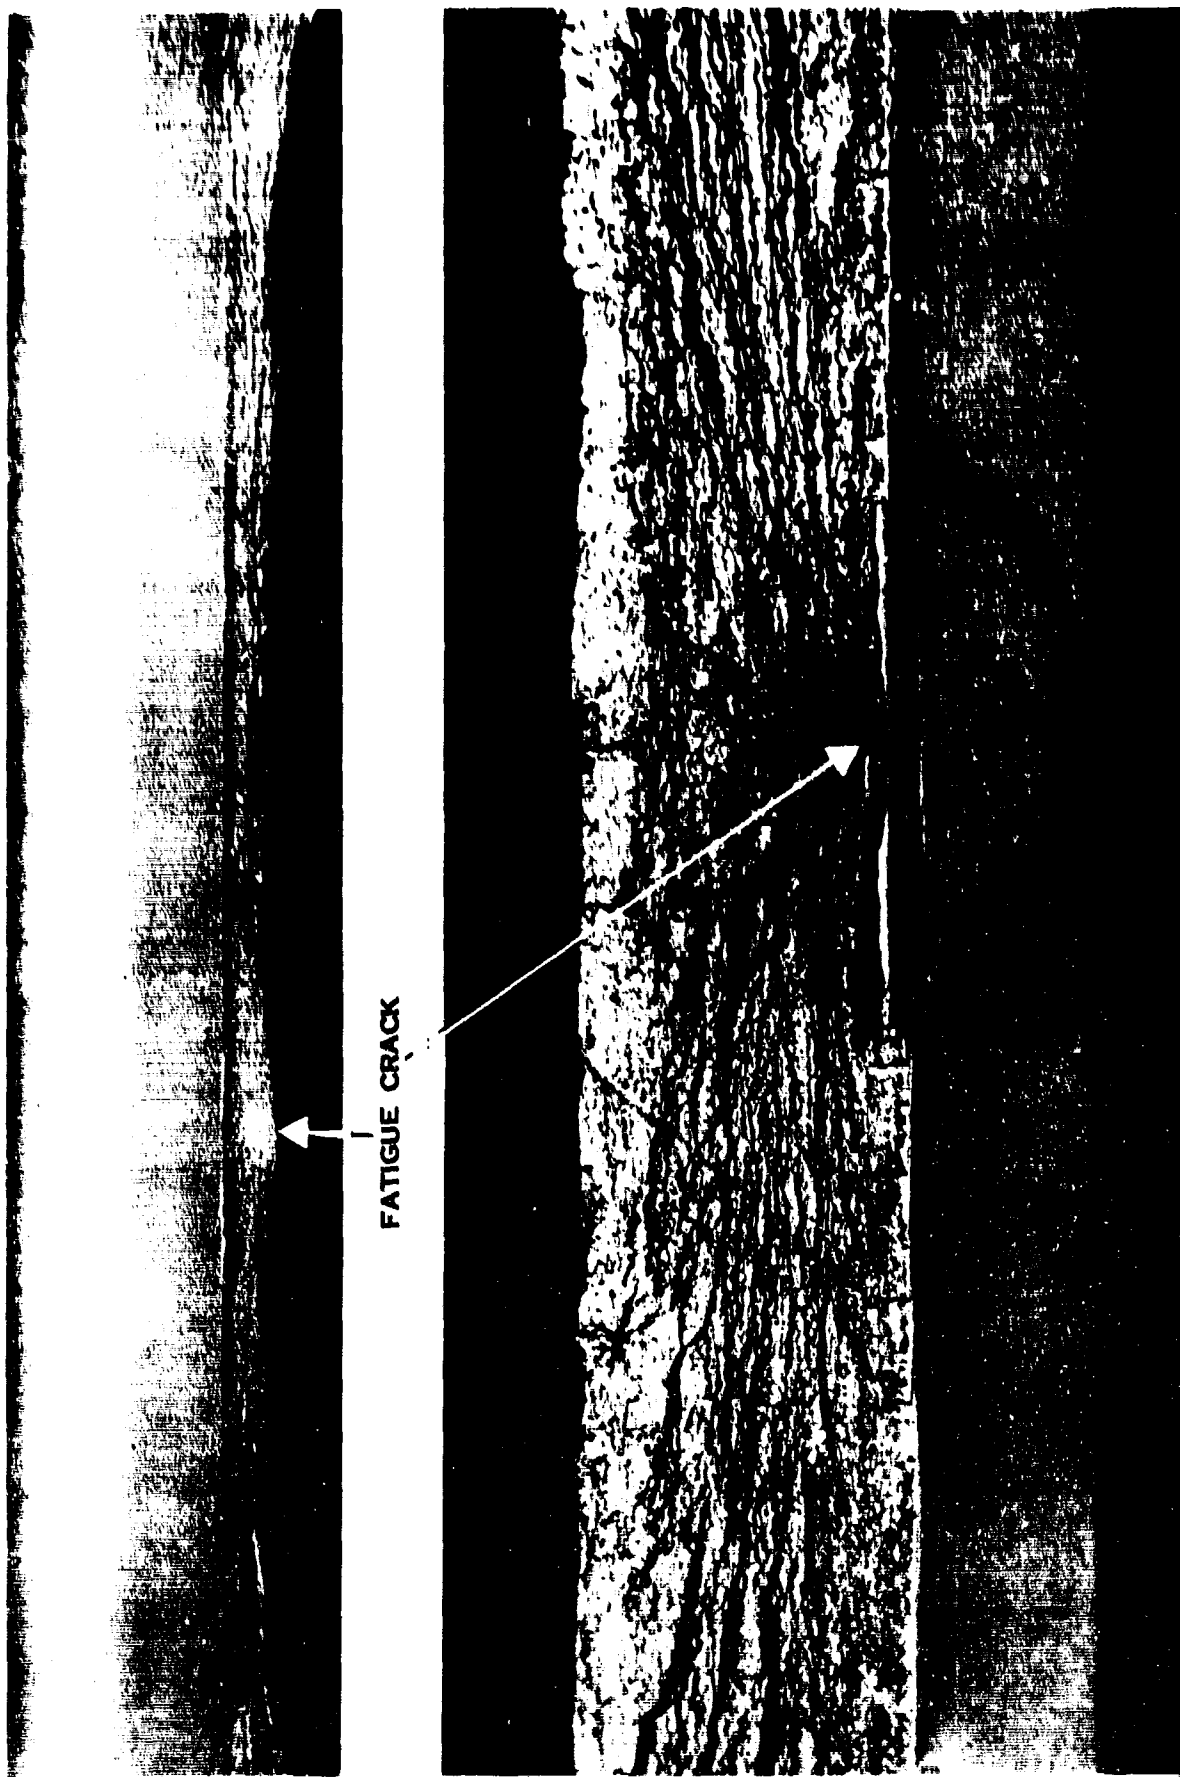
FRACTURE OF 7079 - T6 CYLINDER NO. 7 RESULTING FROM FATIGUE CRACK  
PROPAGATING FROM OUTSIDE SURFACE (WALL THICKNESS 0.306 IN.)

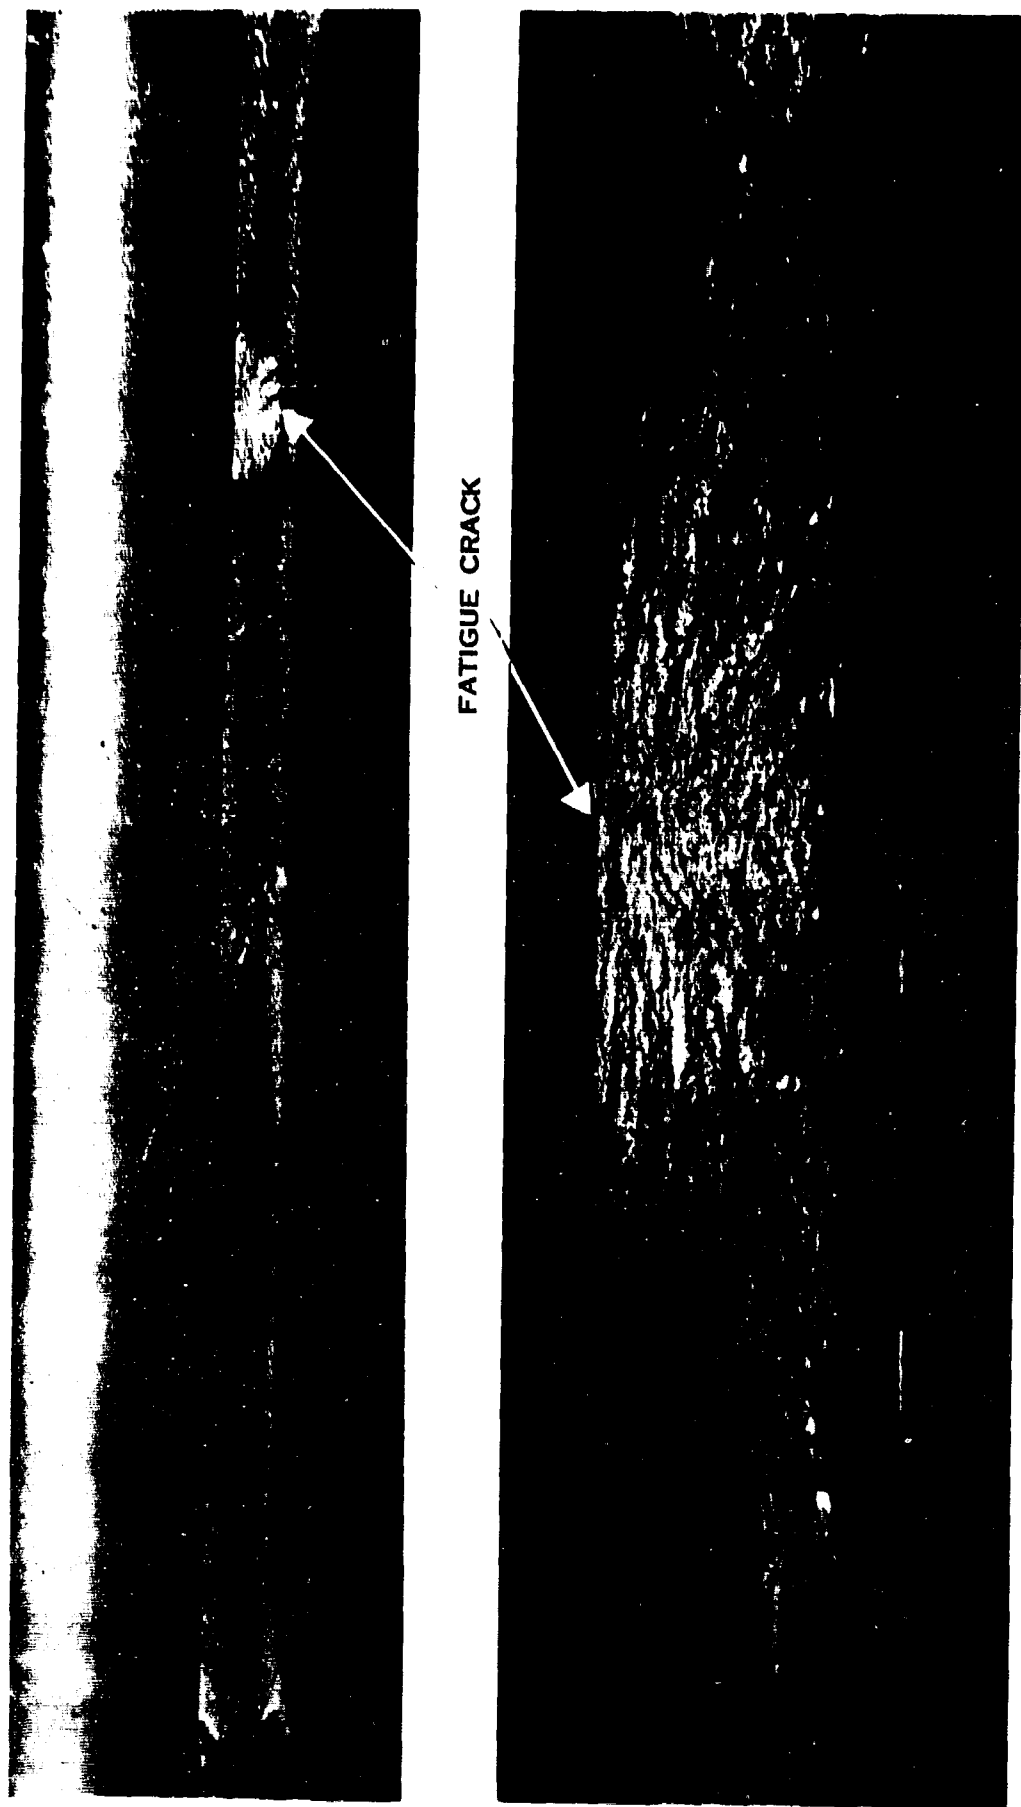
FRACTURE OF 7075 - T73 CYLINDER NO. 7 RESULTING FROM FATIGUE CRACK  
PROPAGATING FROM INSIDE SURFACE (WALL THICKNESS 0.350 IN.)

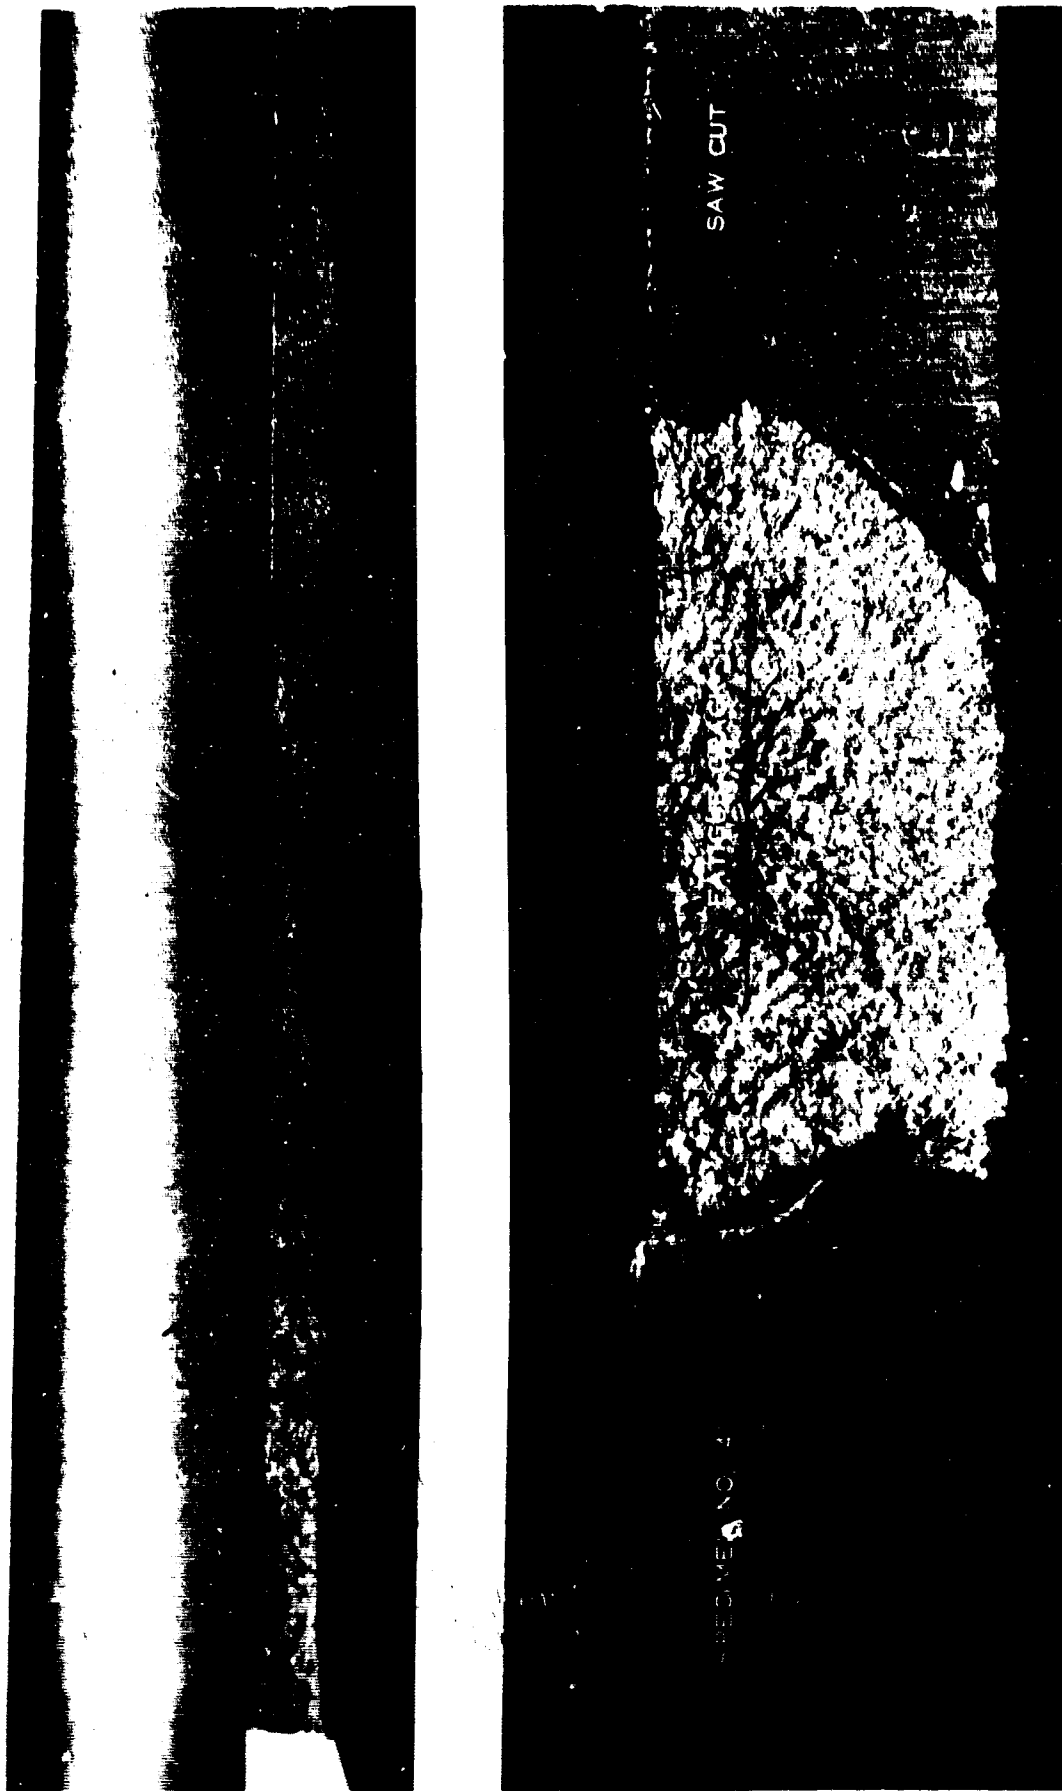
FAILURES OF CH70-T7 CYLINDERS RESULTING FROM FATIGUE CRACKS  
PROPAGATING FROM INSIDE SURFACE (WALL THICKNESS 0.364 IN.)

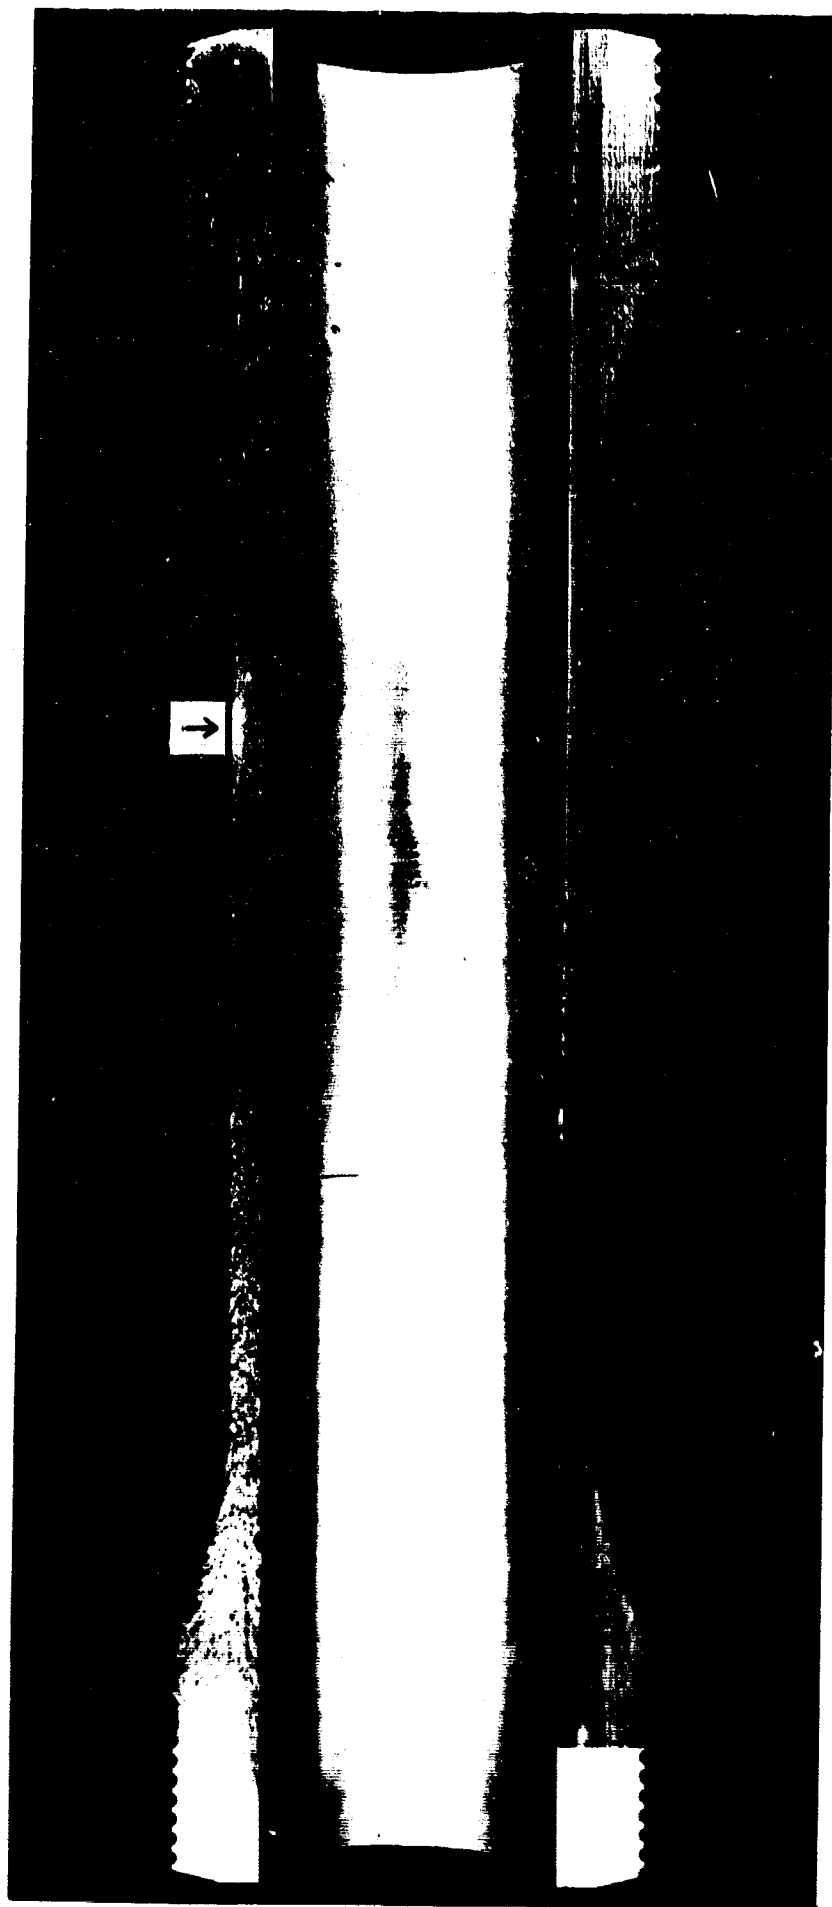
Figure 38

Longitudinal splitting of cylinder in corrosion-fatigue test. Single crack initiation site in 7079-T6 cylinder is indicated by arrow.

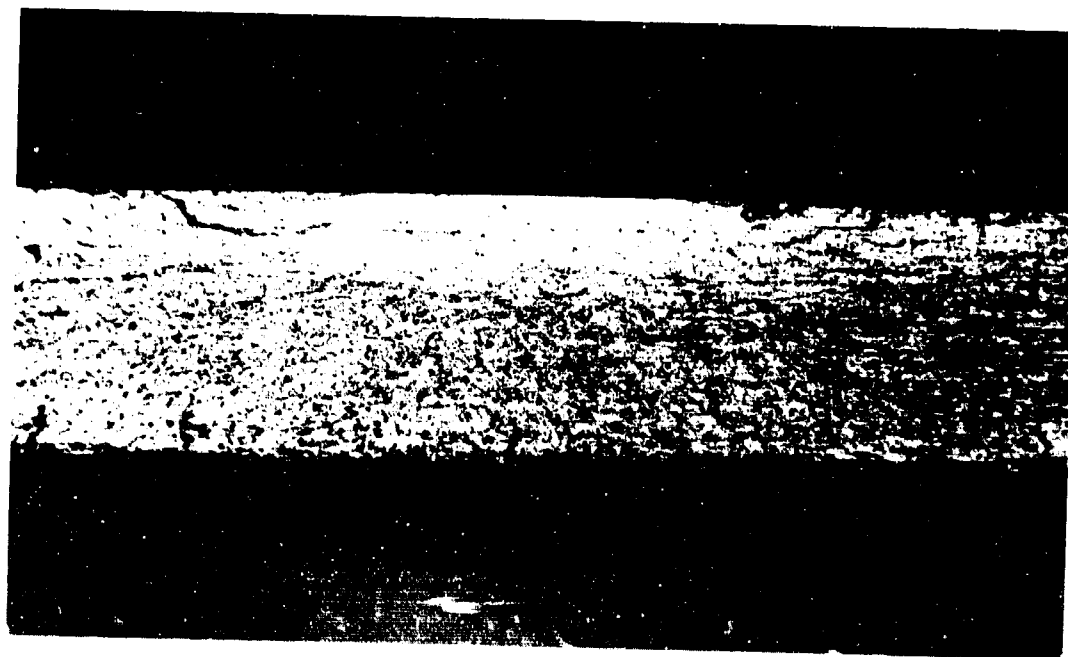
Figure 39

Single initiation site in Fig. 38 at higher magnification, showing gradual transition from slow-fracture to fast-fracture region (X5).

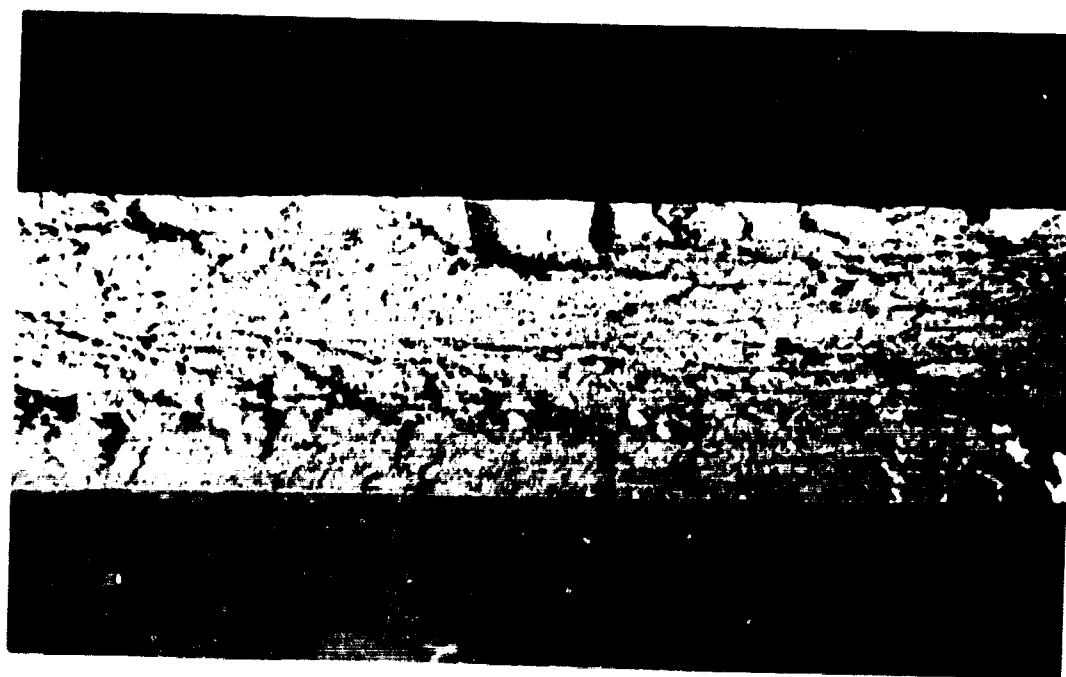
Figure 40

Multiple cracking sites and difference in appearance of slow and fast-fracture regions characteristic of 2014-T6 and 7075-T6 cylinders in corrosion-fatigue test (X5).

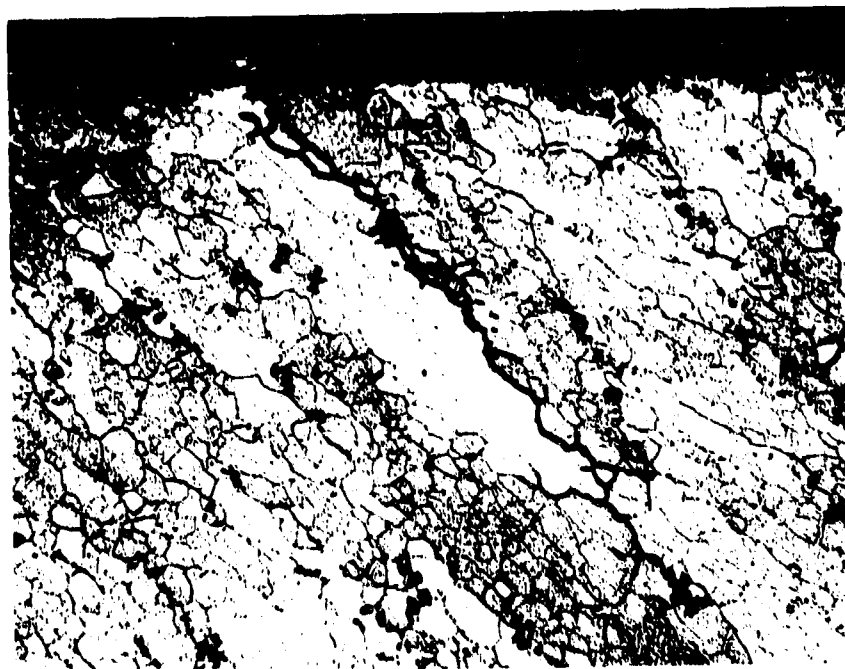
Figure 43

Intergranular and interfragmentary path of one of the auxiliary cracks (Fig. 42) in 2014-T6 cylinder in corrosion-fatigue test (X500).

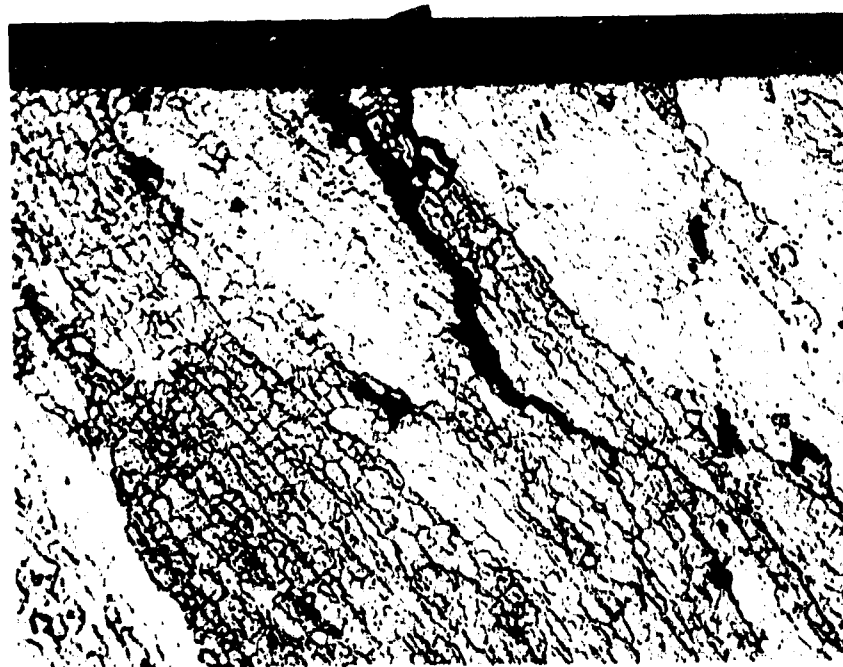
Figure 44

Intergranular and interfragmentary path of auxiliary crack (Fig. 41) in 7075-T6 cylinder from corrosion-fatigue test (X500).

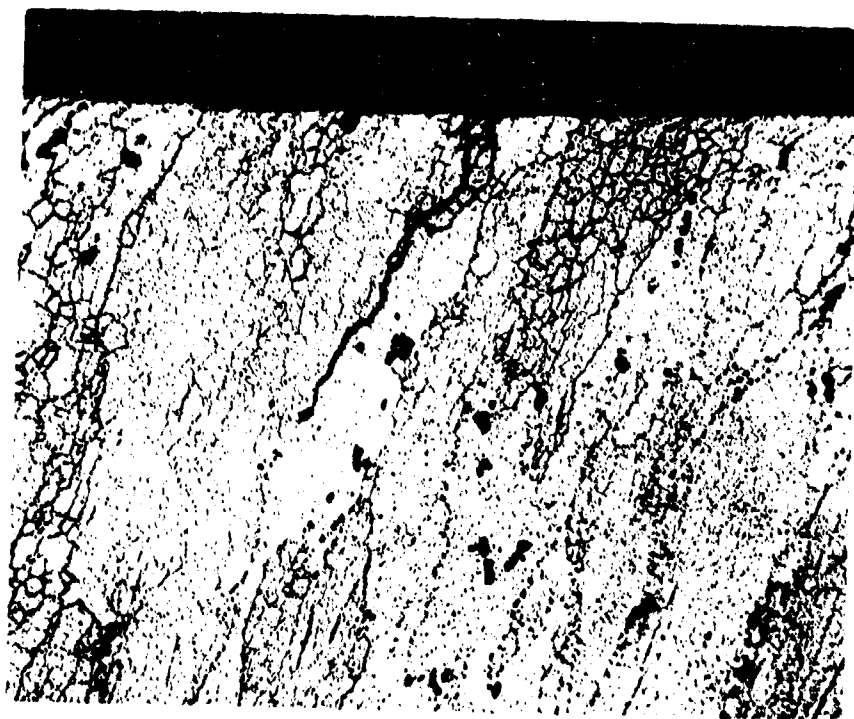
Figure 45

Intergranular and interfragmentary path of auxiliary crack in 7075-T6 cylinder from stress-corrosion test (X500).

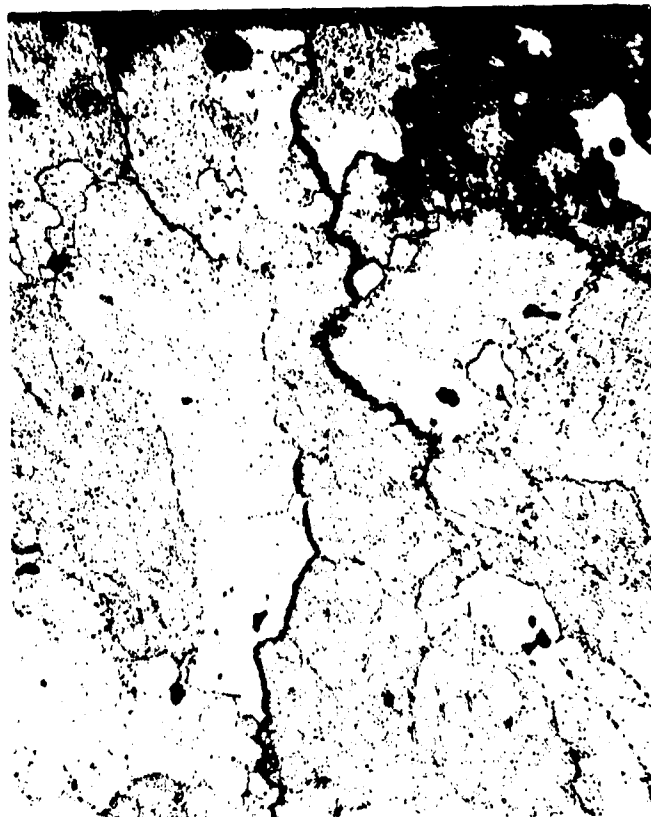
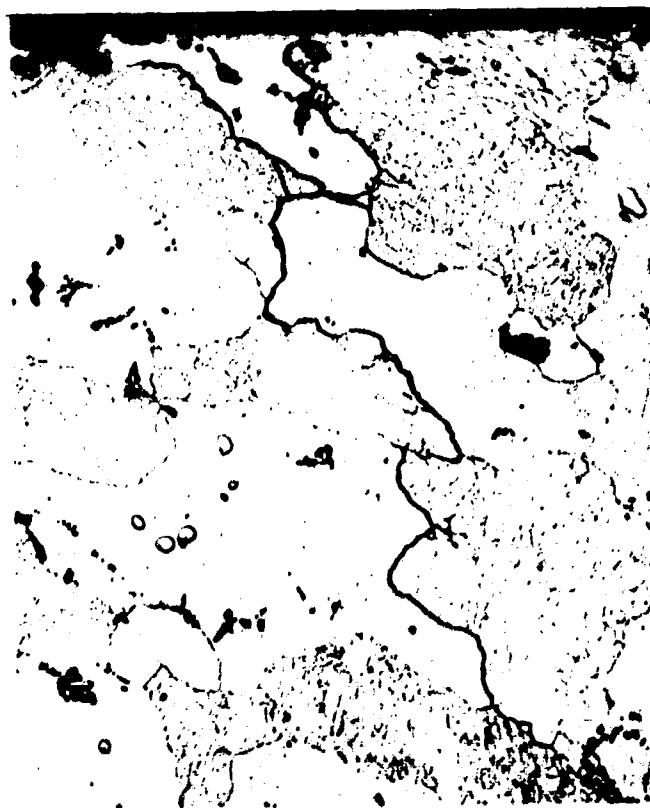
Figure 46

Cross sections of auxiliary cracks in cylinders  
from rod exposed to corrosion-fatigue test (X500).

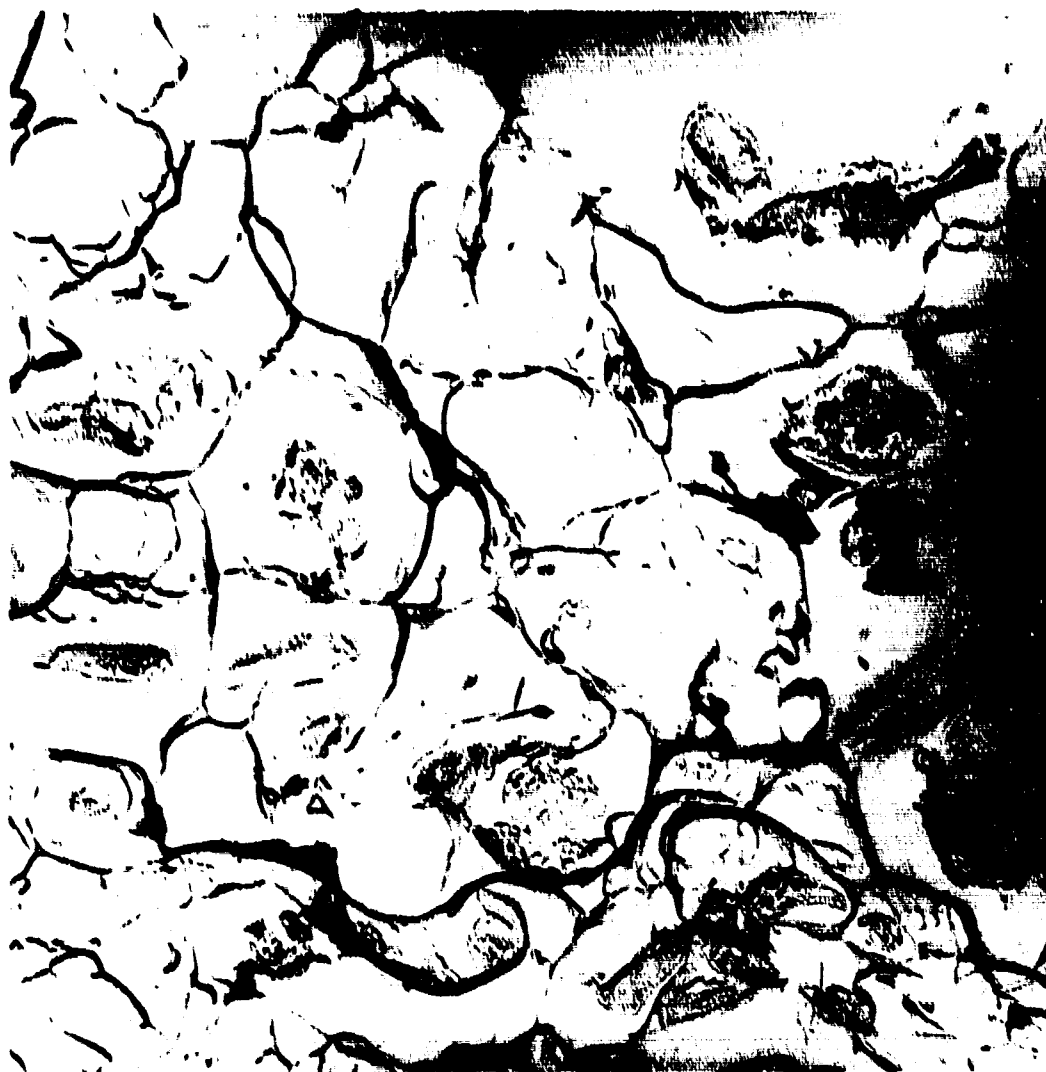
Figure 52

Transmission electron micrograph typical of fracture appearance in slow-fracture region of 7079-T6, 7075-T6 and 2014-T6 cylinder in corrosion-fatigue test (X15,000).

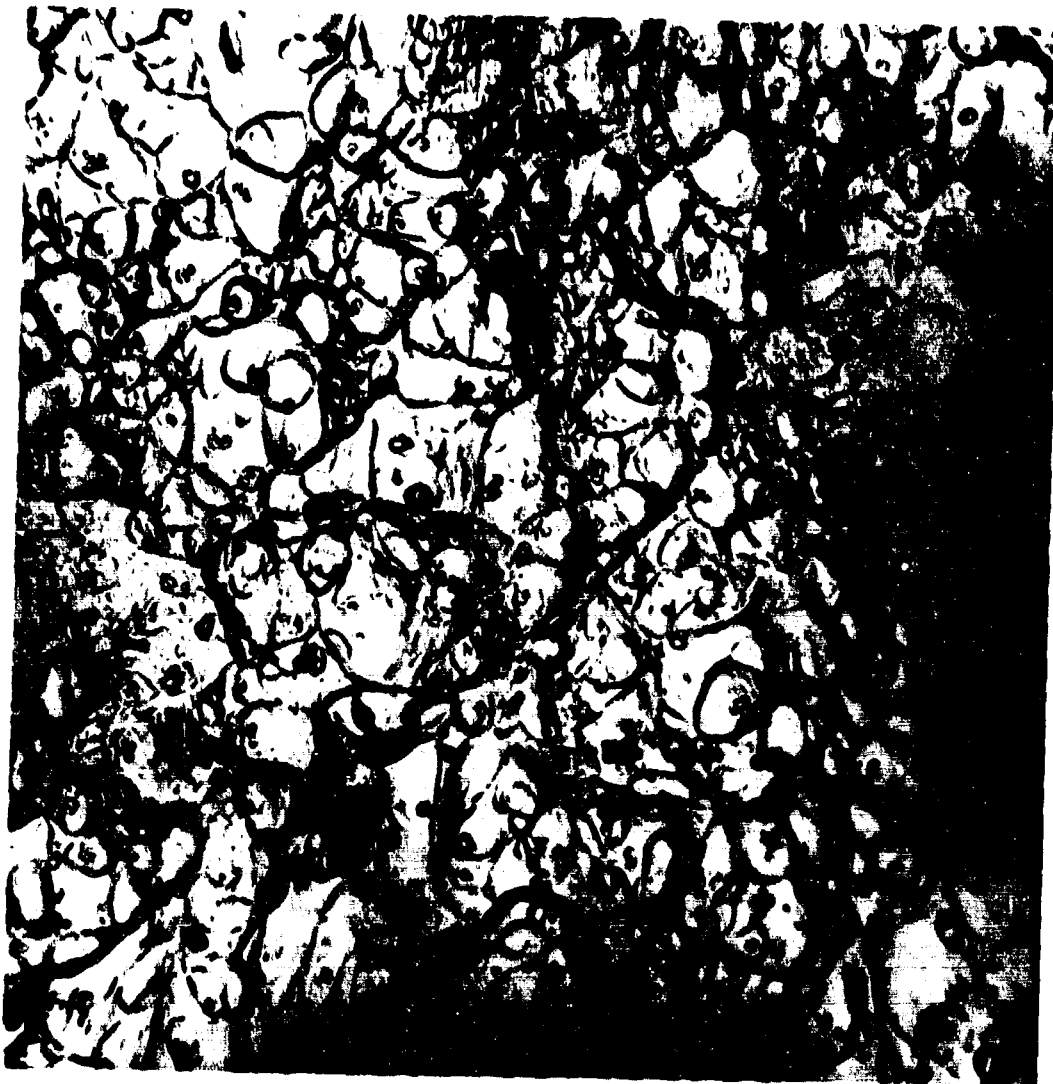
Figure 53

TEM showing dimpled rupture characteristic of tensile failure in fast-fracture region of cylinders in corrosion-fatigue test (X15,000).

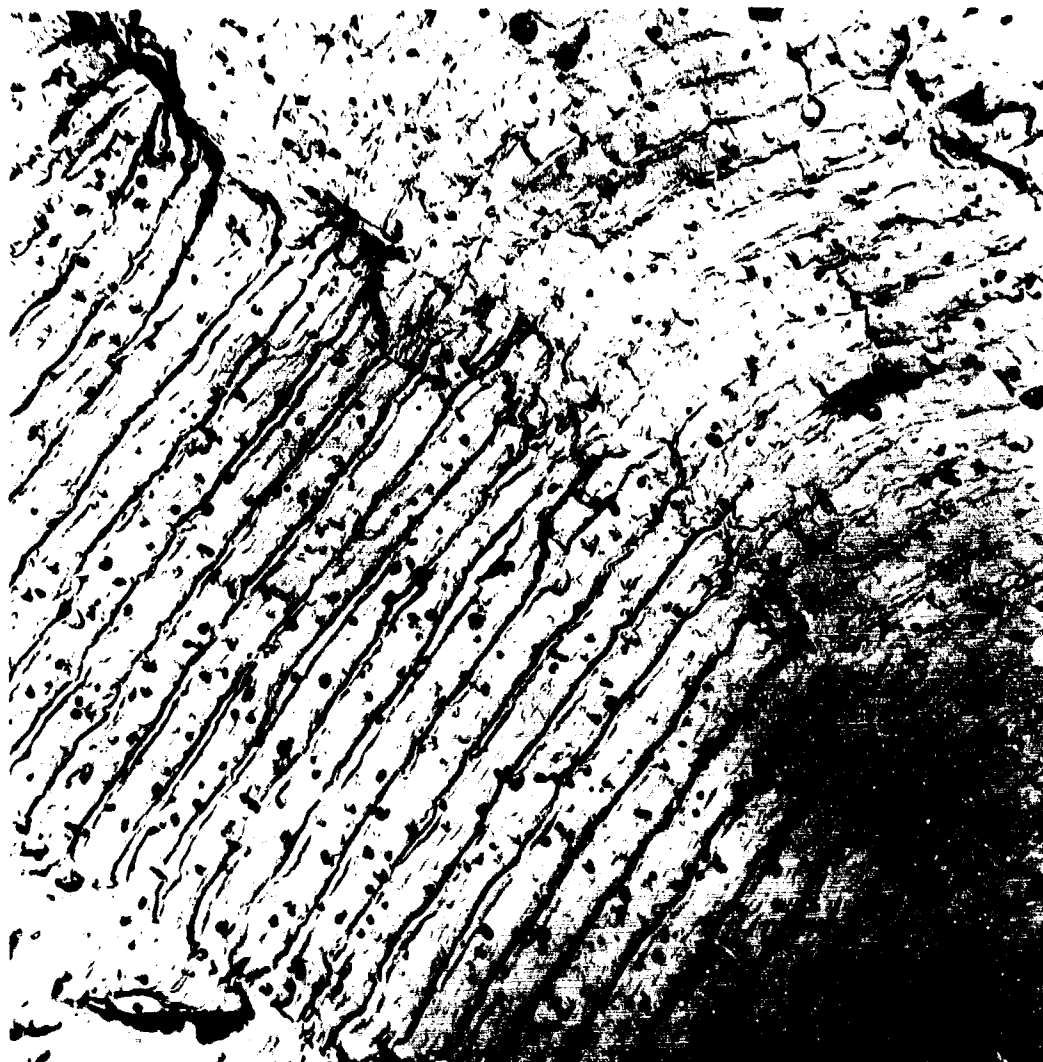
Figure 54

TEM showing striations typical of fatigue failure in slow fracture region of cylinders in corrosion fatigue test (X15,000).

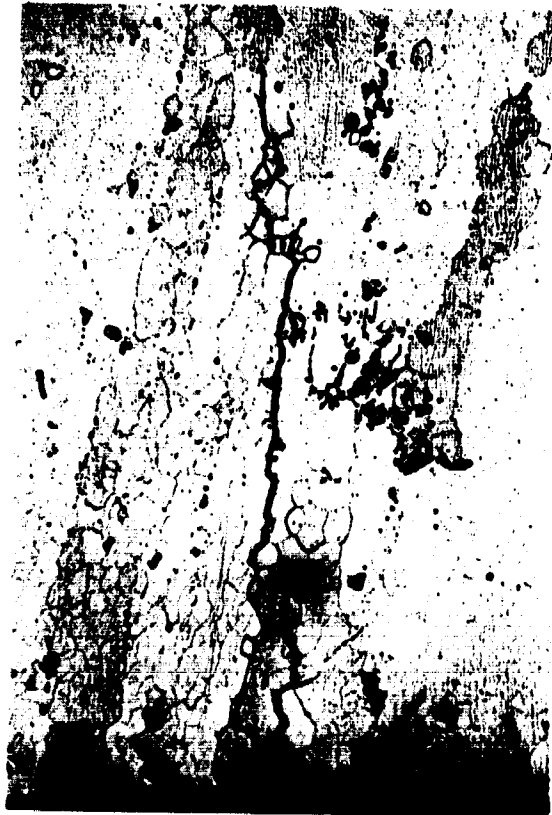
Figure 56

Fracture origin (X50)

Fracture surface (X200)

Cross section (X500)

Granular appearance of fracture and intergranular path of auxiliary crack in 2014-T6 cylinder.

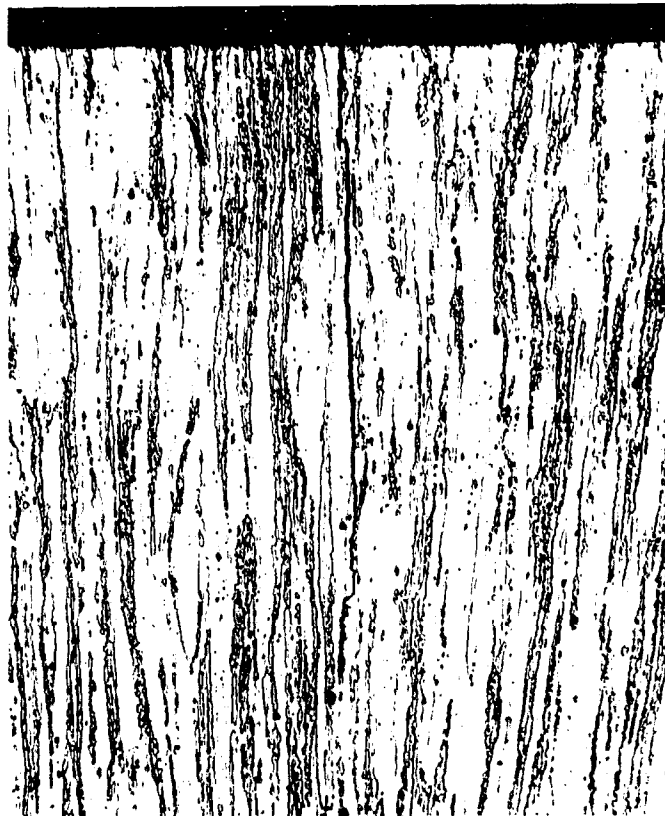
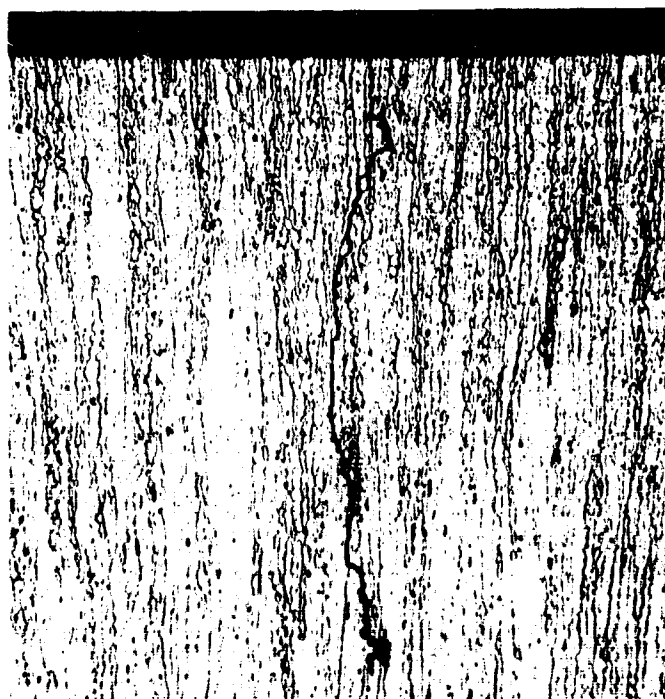
Figure 61

- b Cross sections of auxiliary cracks in C-Rings  
indicating mixed fracture mode (X100).

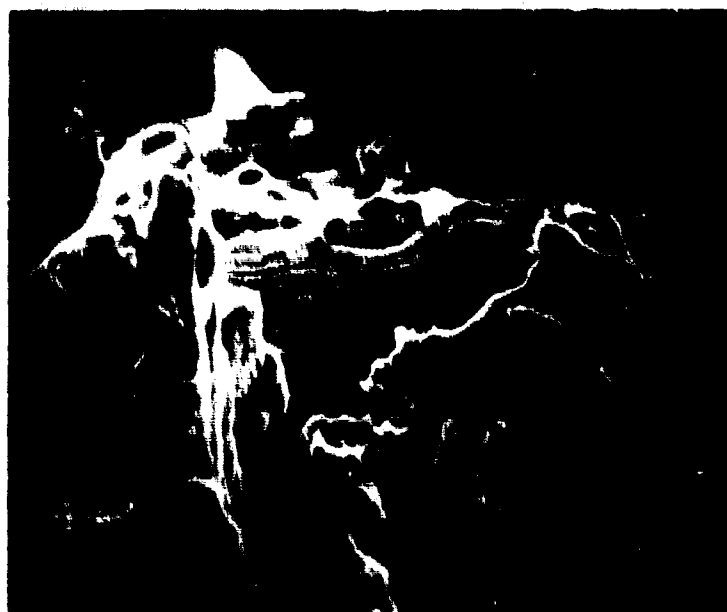
a Intergranular penetration and pitting on grain surfaces (X850).

b Fatigue striations near end of slow-fracture region (X1300).

SEM of fracture surface of cylinder from 2014-T6 rod having long life in corrosion-fatigue test.
